Geological Investigation

(Sediment and Creek Bank Soils)

Continental Steel Superfund Site—Contract 2 Geological (Sediment and Creek Bank Soils) Investigations

TO: USEPA
FROM: CH2M HILL
DATE: December 24, 2001

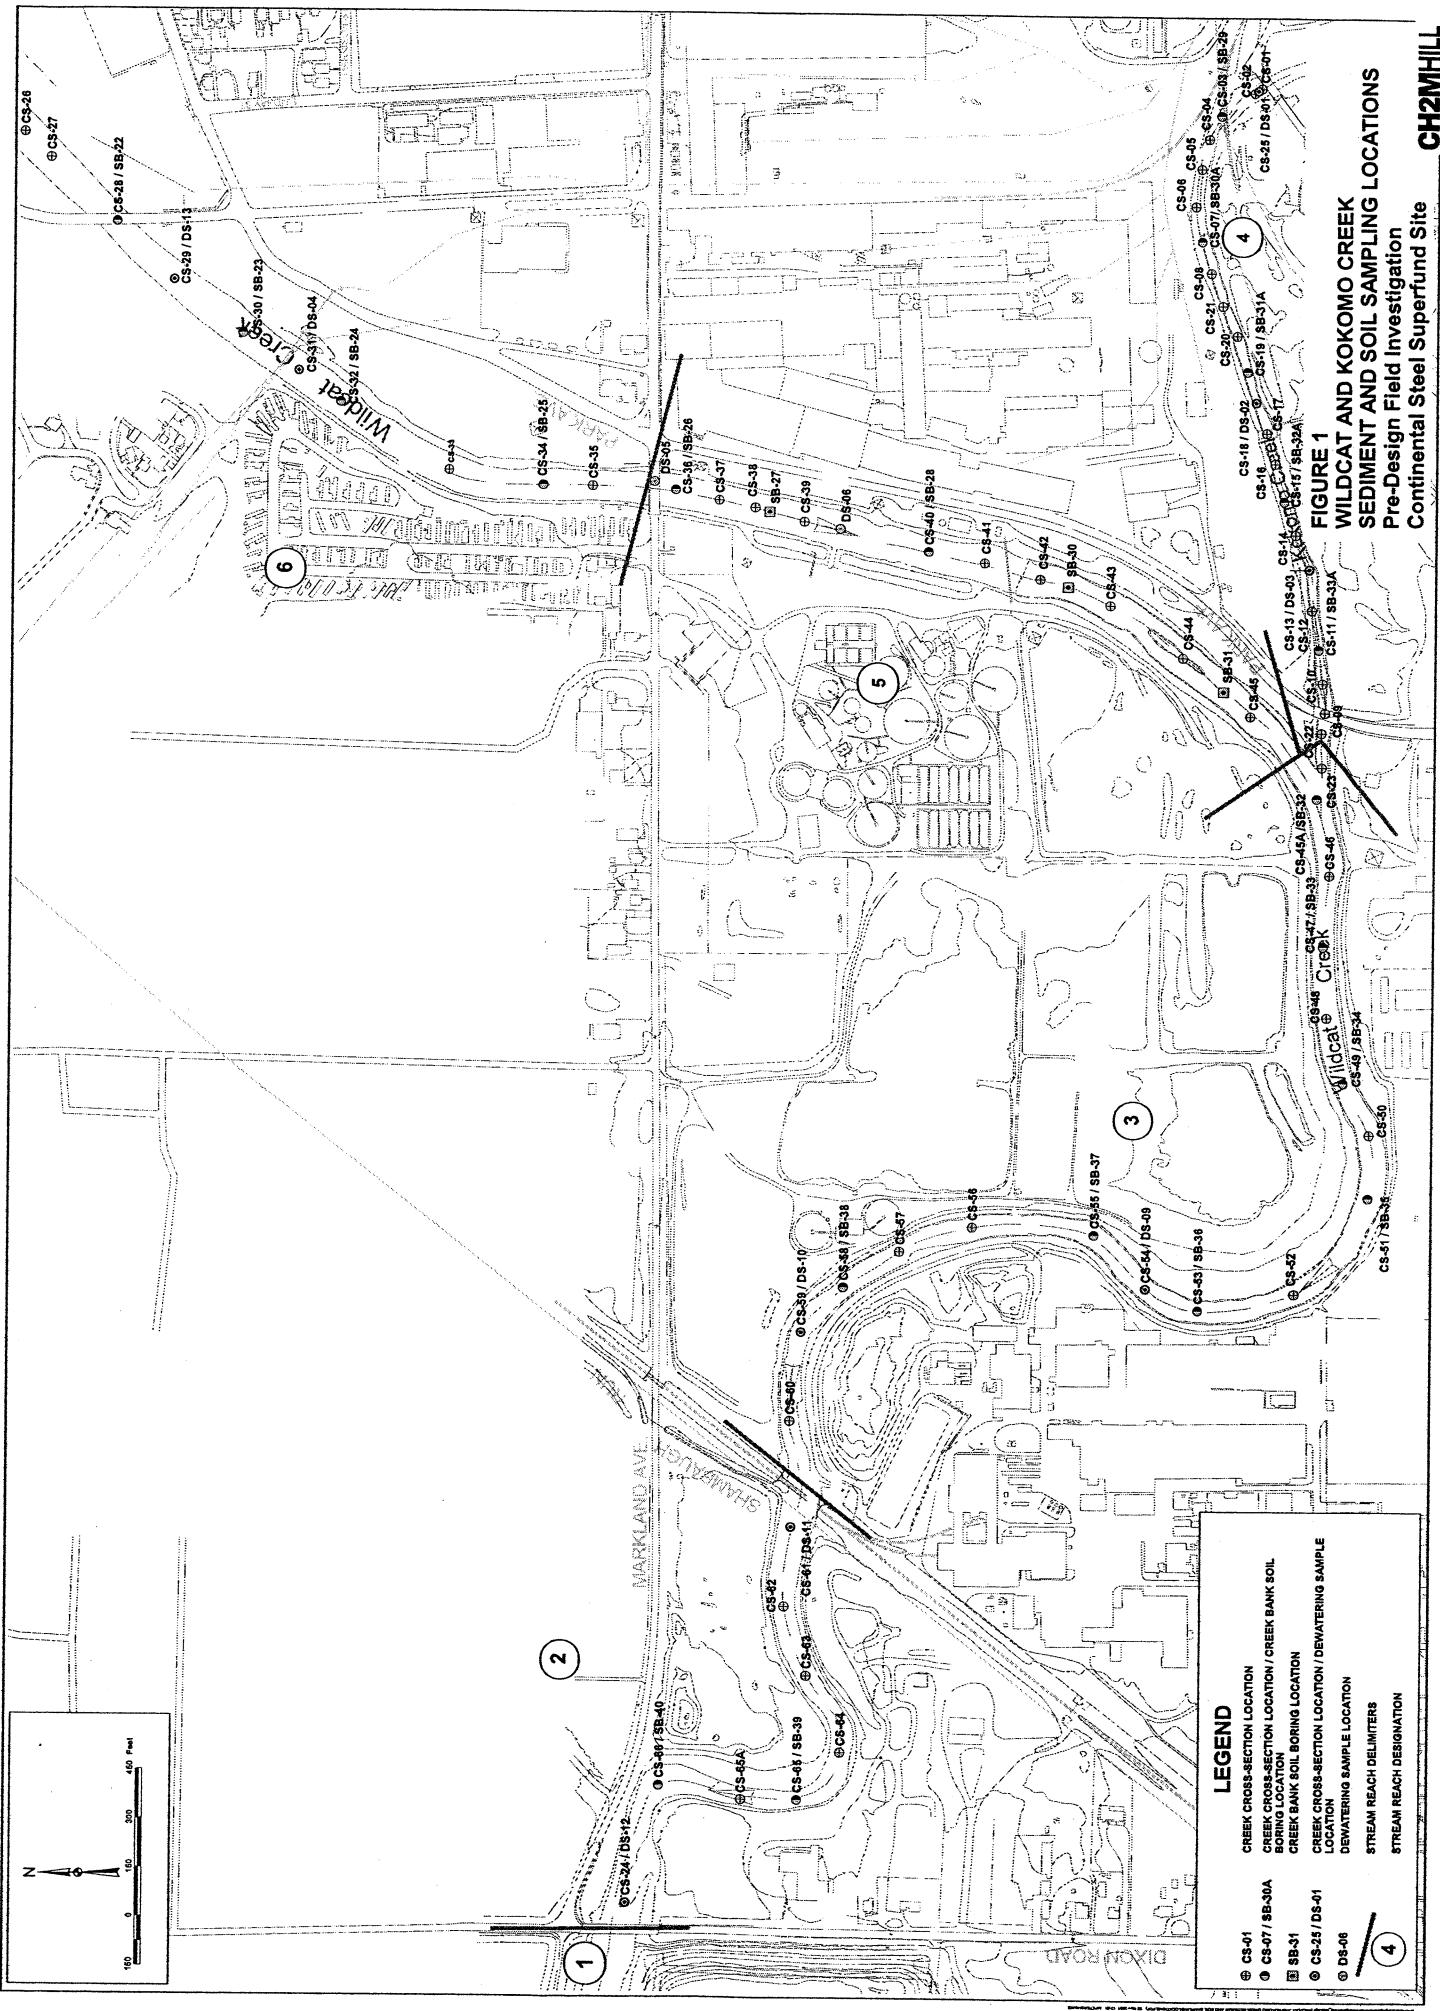
FIGURE 1
WILDCAT AND KOKOMO CREEK
SEDIMENT AND SOIL SAMPLING LOCATIONS
Pre-Design Field Investigation
Continental Steel Superfund Site

Deviations. Three cross section locations (CS-26, CS-38, and CS-39) were adjusted slightly in the field because of the conditions encountered at the cross section locations. In addition, one location (CS-65A) was added in Wildcat Creek and several were added in Kokomo Creek. The adjacent table compares the number of original cross section locations versus actual locations completed in the field. See Figure 1 for additional detail.

Thirteen sediment samples were collected in Wildcat and Kokomo Creeks for qualitative dewatering testing (Figure 1; Tables 4 and 5). The dewatering test results will be used to evaluate the post-excavation sediment handling requirements.

Deviations. Three soil boring locations (SB-30, SB-31, and SB-39) were adjusted because of access or soil penetration issues (Figure 1). The team was unable to collect a sample at the most upstream planned location on Wildcat Creek due to the presence of large rocks. Also, location identifiers SB-30 through SB-33 initially were duplicated—one set at locations on Kokomo Creek, the other at locations on Wildcat Creek. This duplication was corrected by renaming the locations on Kokomo Creek SB-30a through SB-33a (Table 7).

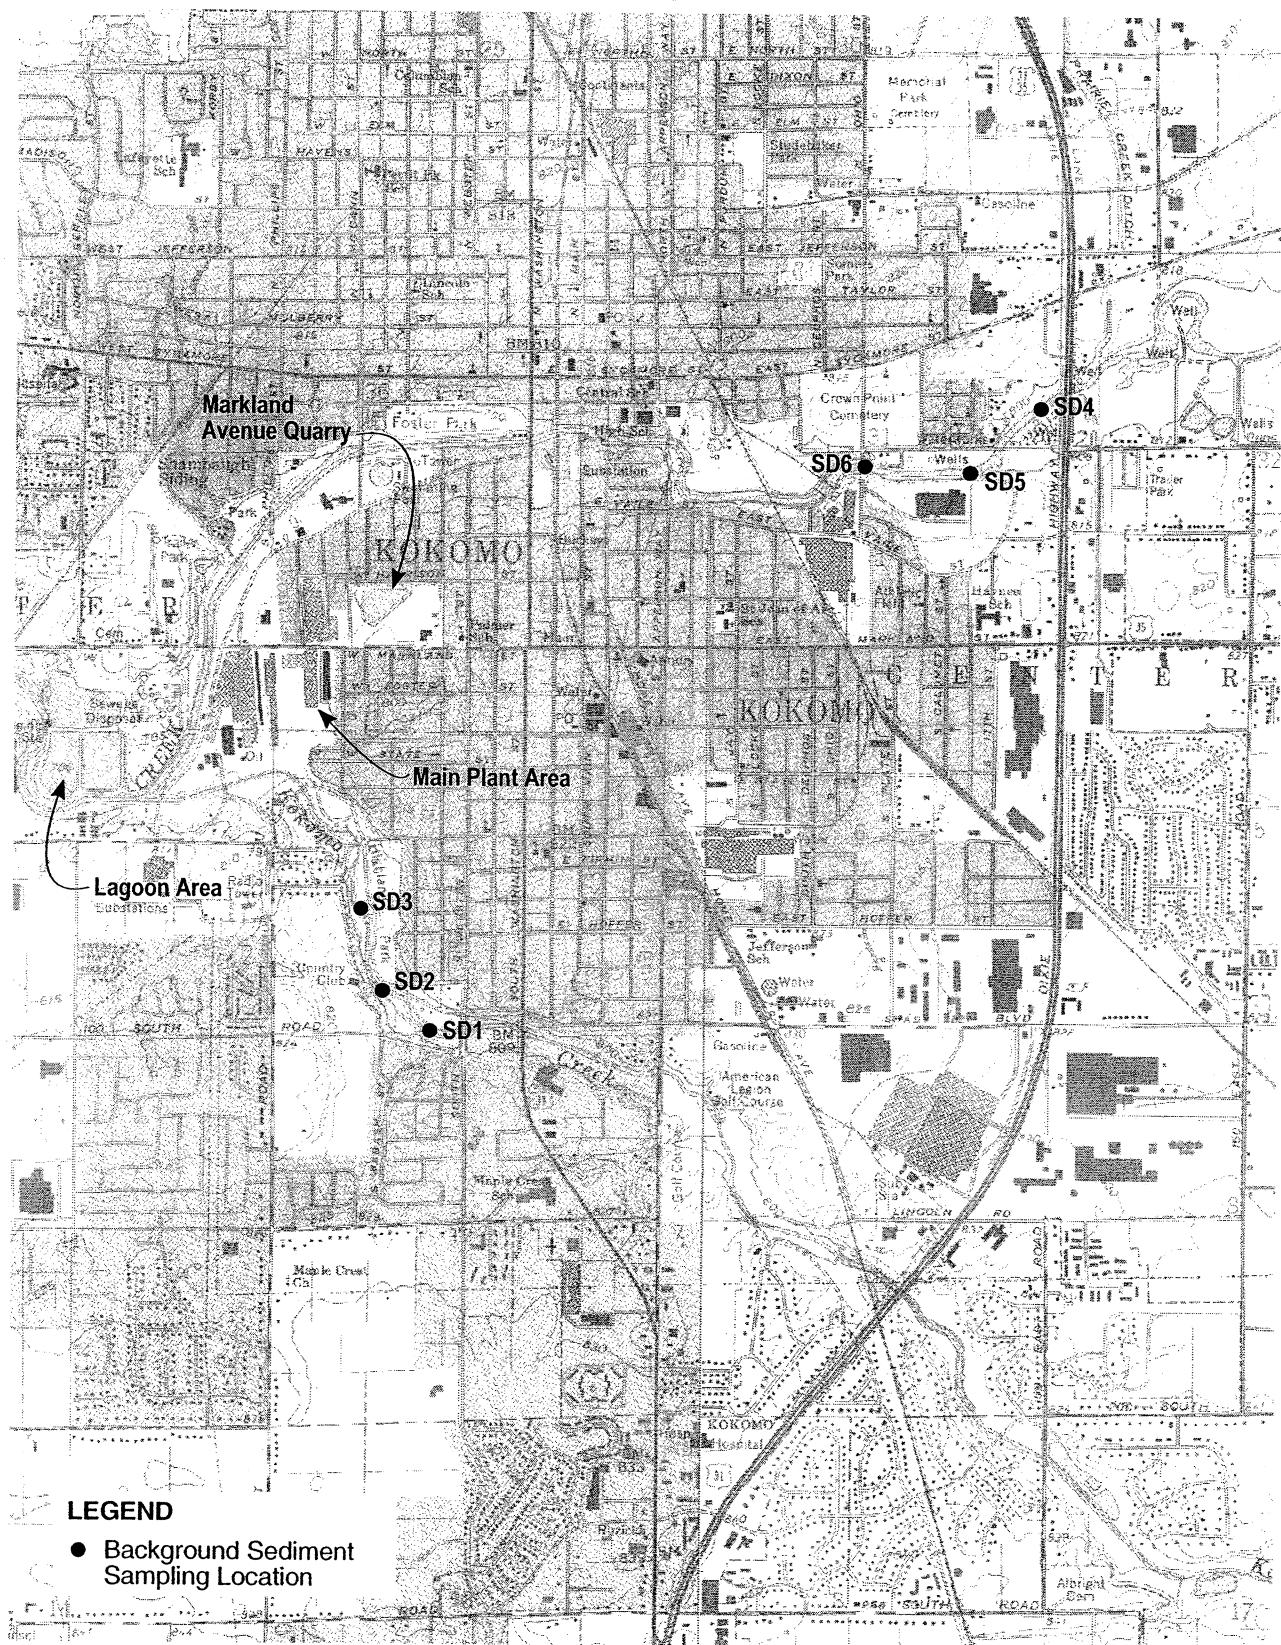
FIGURE 2
Background Sediment Sampling Locations
Pre-Design Field Investigation
Continental Steel Superfund Site

Sediment samples were collected at three upstream background sample locations for each creek (Figure 2). These samples were analyzed for polynuclear aromatic hydrocarbons (PAHs), polychlorinated biphenyls (PCBs), arsenic, and beryllium to determine background levels for the creeks (Table 6).
